MEMORANDUM

TO: Paradise Hills HOA
FROM: Element Engineering
DATE: April 21, 2019
SUBJECT: Sunrise Drive Hydraulic Assessment

PURPOSE

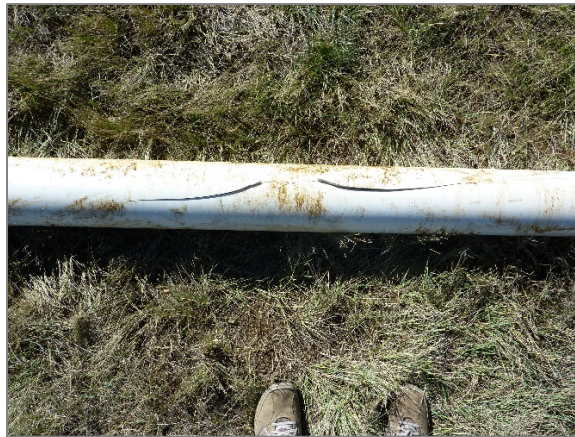
The PHHOA has historically experienced numerous costly main breaks on this lateral. Recent breaks have been documented on April 15, 2016, November 14, 2017, July 11, 2018, October 20, 2018, and November 13, 2018. An example of a break in the Sunrise Drive lateral, in this case a lateral fracture, is shown in Figure 1.

Figure 1 - November 10, 2018 Lateral Break

Modeling clearly confirms the pressures in Sunrise Drive range between approximately 123 PSI and 168 PSI. As previously discussed, the installed pipe is white 6-inch diameter DR18 C900 with a 150 PSI pressure rating stamped on it. Therefore, most of the Sunrise Drive lateral is likely under higher pressure than the

installed pipe is specified for. It is possible that this is either contributing to or exacerbating the lateral breaks in this area.

It is impossible to determine the exact cause of the breaks without further analysis of the pipe itself. However, the similar pipe material (size and pressure rating) and similar pressures seen on Monte Vista Road (adjacent to Sunrise Drive) without chronic lateral breaks would point to a wider issue than just local pressures.

Ultimately the HOA must determine, based on the availability of funds, if a short-term potential solution or long-term ultimate solution is desired. If funds are available Element Engineering recommends Alternative No. III – Replace Sunrise Drive Lateral and Install a PRV. While the costliest, this alternative offers several major advantages. These are:

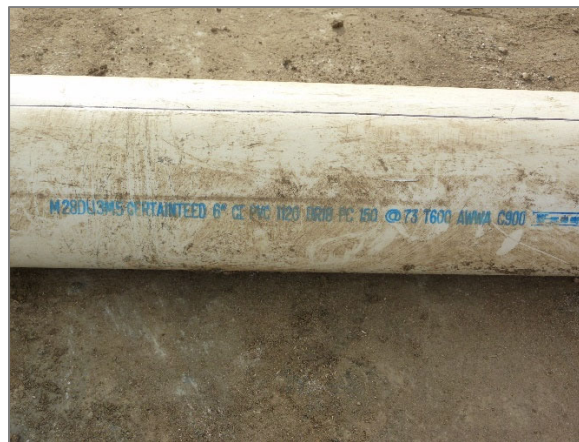
According to as-built documentation (attached to this memorandum) the Sunrise Drive lateral was installed in 1988. As-builts show a total of 1,849 linear feet of 6" Blue Brute PVC, 18 service connections, four (4) hydrant and hydrant assemblies (hydrant, valve, fire line), and three (3) gate valves. Excavations to fix water main breaks has shown the installed pipe to be white C900 DR18 PVC with a 150 PSI pressure rating stamp. Figure 2 shows pipe excavated to fix a break.

Figure 2 - Pipe Excavated from Sunrise Drive

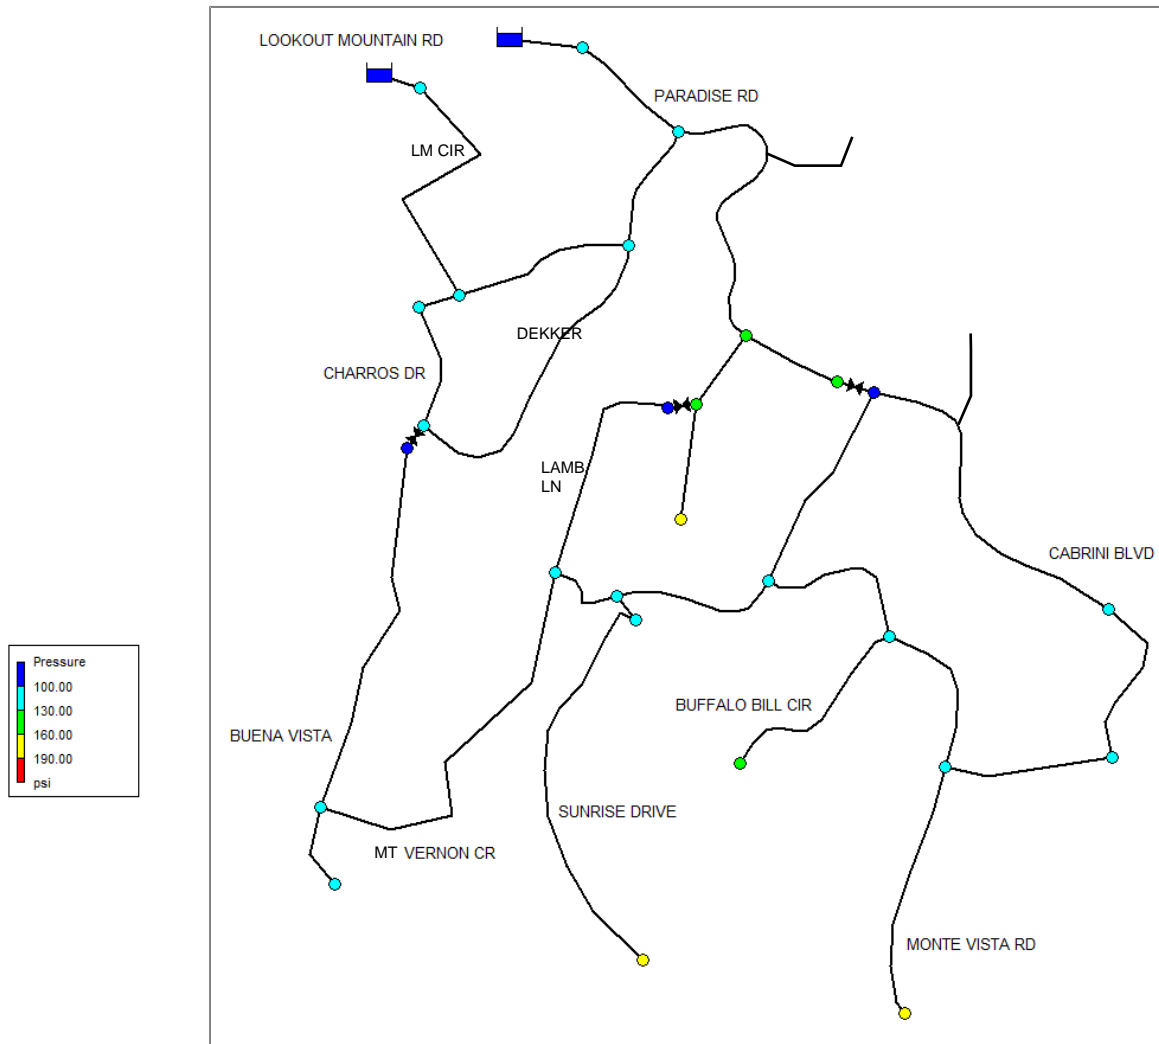
The model simulated pressures in the Sunrise Drive lateral within four (4) PSI. For the purposes of this analysis this is a very accurate approximation. Water pressure at the top of Sunrise Drive was shown to be

approximately 123 PSI and the pressures at the end (bottom) of Sunrise Drive were modeled to be 168 PSI. therefore, it can be assumed that the pressure along Sunrise Drive ranges between these two values. An exhibit depicting the water model is shown in Figure 3. Note that this models only the portions of the PHHOA system necessary to determine pressures on Sunrise Drive. Modeled pressures throughout the system are shown in the attached PHHOA Lateral and Modeled Pressures map.

Figure 3 - PHHOA Modeling Results (Pressure)
