MEMORANDUM

TO: Paradise Hills HOA
FROM: Element Engineering
DATE: April 21, 2019
SUBJECT: Sunrise Drive Hydraulic Assessment

PURPOSE

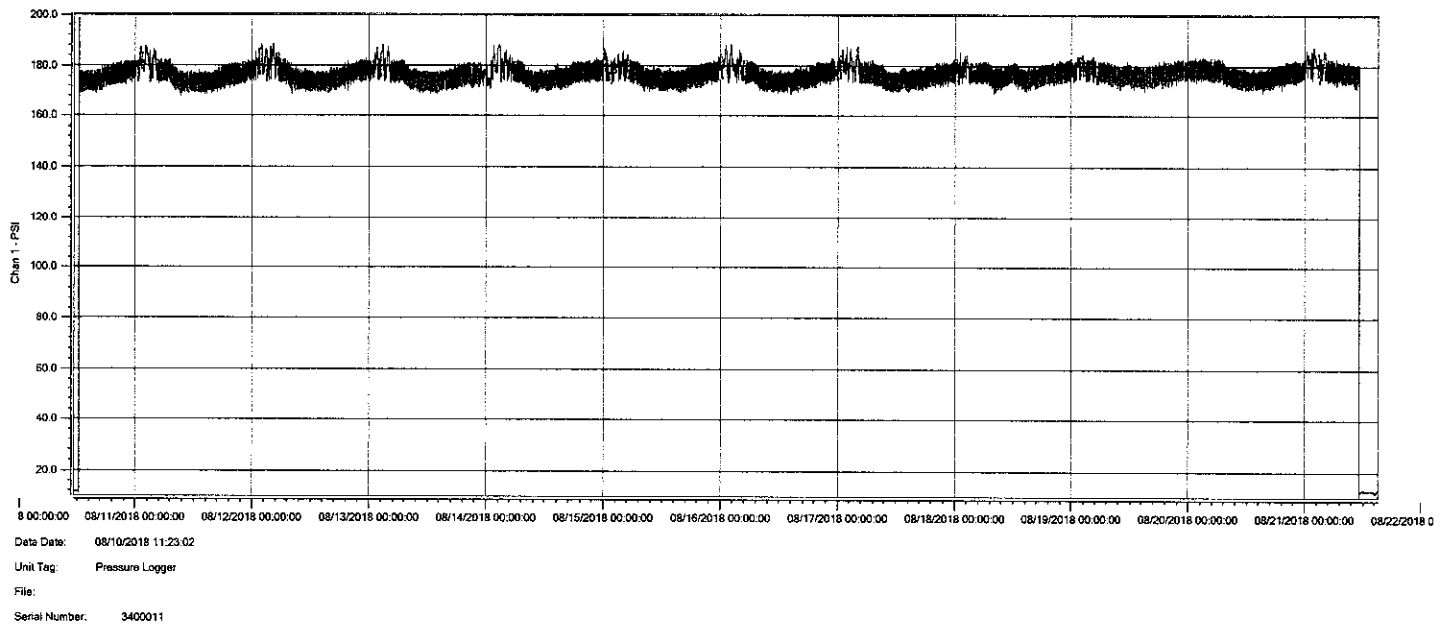
Summary

Chan	Chan Tag	Chan Type	Eng Units	Max	Min	Total Samples	Average	MKT	Start Time	Stop Time
Chan 1	Chan 1	Pressure	PSI	198.7	9.8	32136	173.5		08/10/2018 11:23:02	08/21/2018 15:10:32
