Subject: Geotechnical Engineering Services, Proposed Fire Station at 543 Paradise Road, Genesee, Colorado

Martinez Associates, Inc. (Martinez) has completed an initial evaluation of the property at 543 Paradise Road as proposed in our proposal of June 1, 2022. This letter presents the results of our site visit and recommendations for additional work at the site.

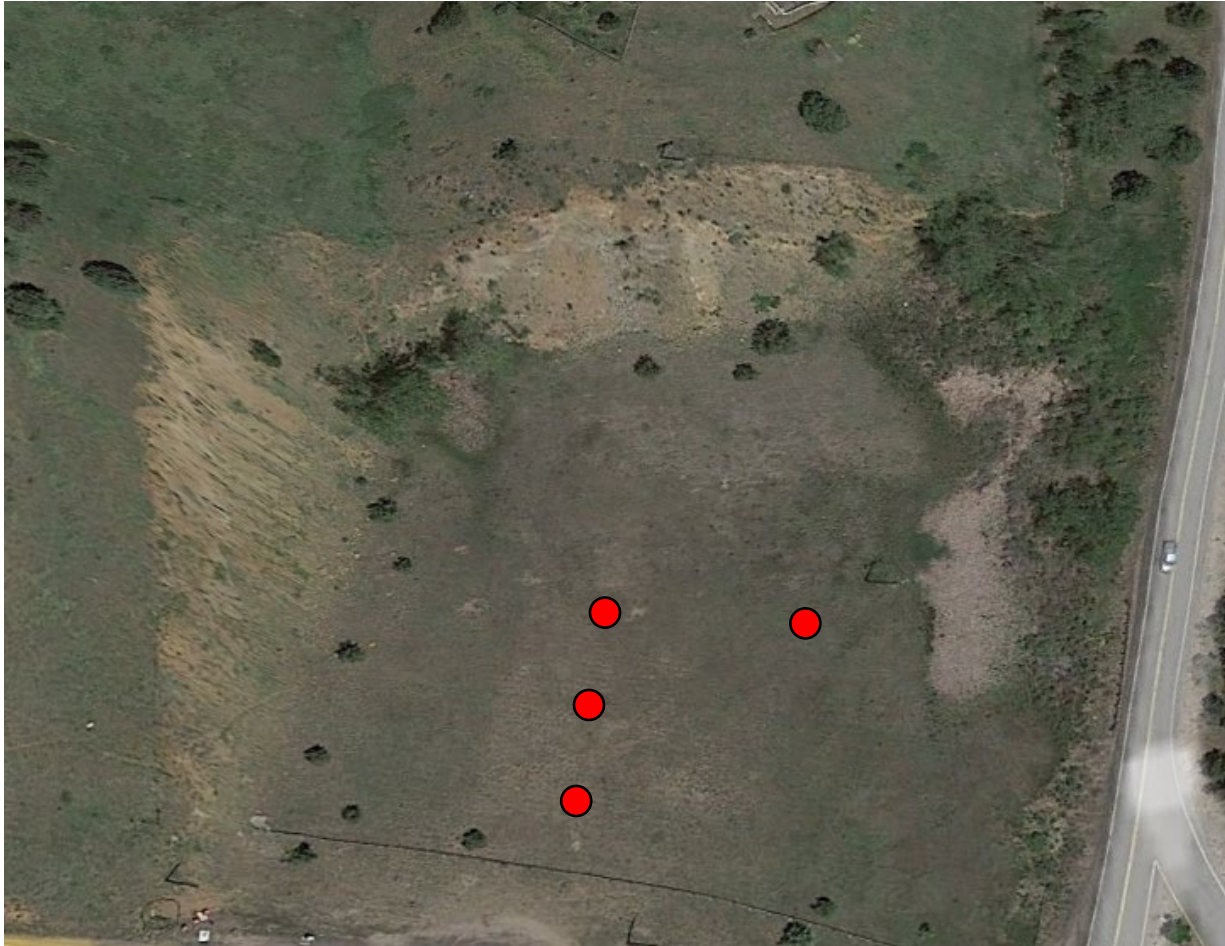
As indicated on Figure 1 attached, four hand dug holes were excavated at the approximate locations shown. All four holes encountered a very thin, 7 to 8 inches, layer of a clayey sand and gravel soil. Beneath the thin soil layer, we encountered hard gneiss bedrock. The bedrock was fractured as fragments of the bedrock could be excavated using a shovel. The moisture content of the soil layer increased in the northern holes and wet conditions were observed along the base of the cut slope on the north side of the property as seen in the lower left side of Photograph 1, attached. There are natural drainages at the northwest and northeast corners of the site so the wet conditions may be the result of surface flows or groundwater flows associated with the drainages or a combination of both.

● Approximate Sample Location

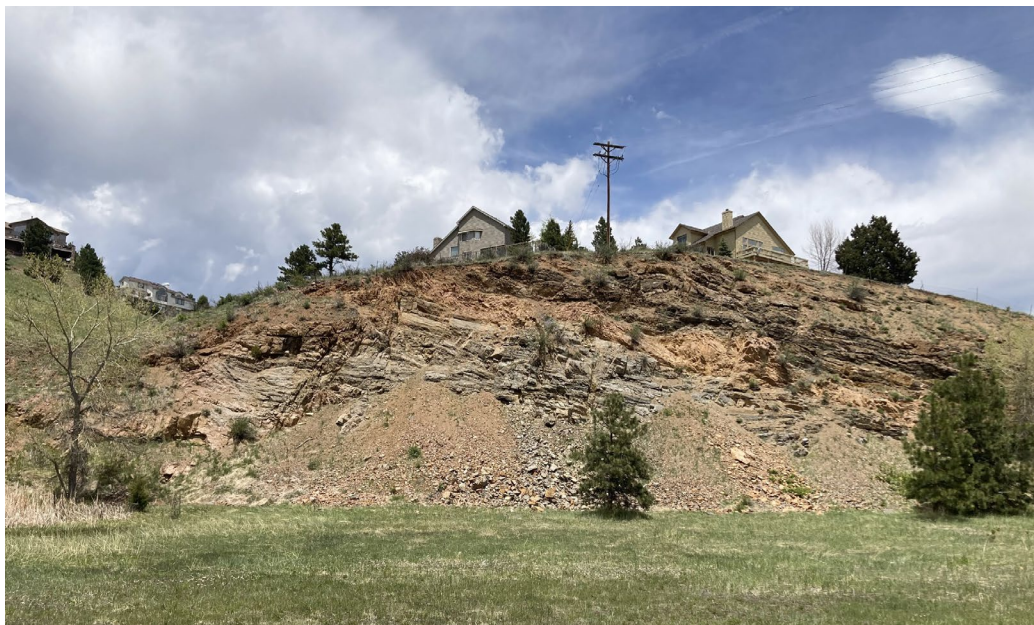
Photograph 1- North Cut Slope

The fractured nature of the hard bedrock is evidenced by the talus slope conditions at the bottom of the cut slopes in Photographs 1 and 2. The fractured nature of the bedrock may also have been a factor in the selection of this site for a borrow source for the I-70 construction. Rockfall from the cut slope should be taken into account during sighting of the building and other developments.
